Manhole Inspection Summary

Manhole # S37AA_017MH

Location Address: **358 e madison st**

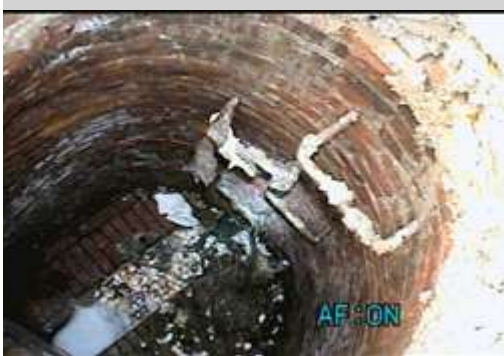
Defect 5

Count: **5** Missing: **0** ☒ **Corroded**

12 Oclock connection under shelf

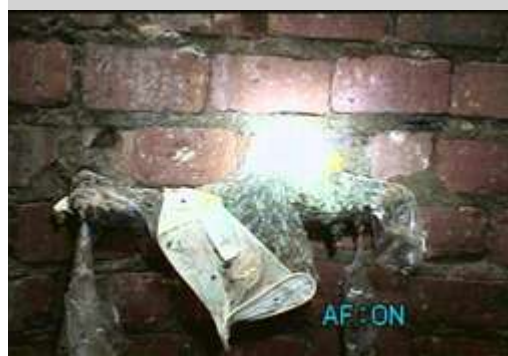
Defect 4

corr steps

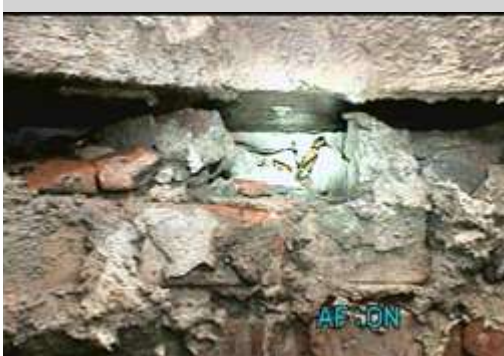
Defect 3

☒ **Evidence Of Surcharge** Depth: **3.2** (ft.) ☐ Active Surcharge Present

surcharge evd

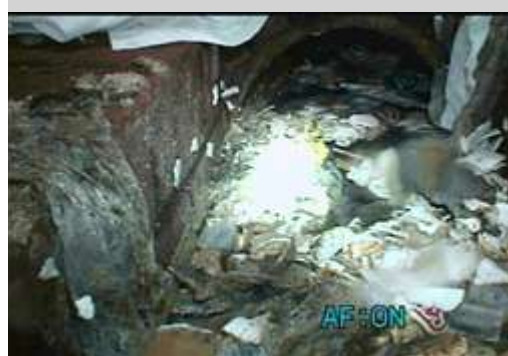
Defect 2

Condition: ☐ Sound ☒ **Cracked** ☐ Root Intrusion ☒ **Loose Brick** ☒ **Deteriorated**

frame adj cracked, loose bricks,
deteriorated

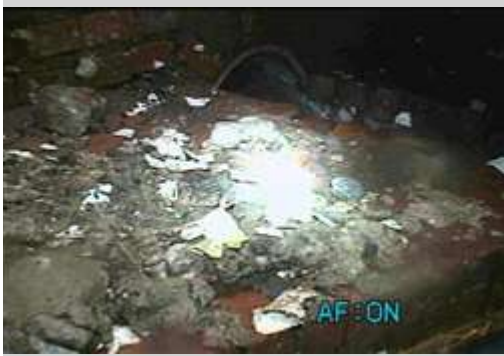
Defect 1

Condition: ☐ Sound ☐ Cracked ☐ Root Intrusion ☐ Deteriorated ☐ Leaks ☒ **Debris**

channel debris

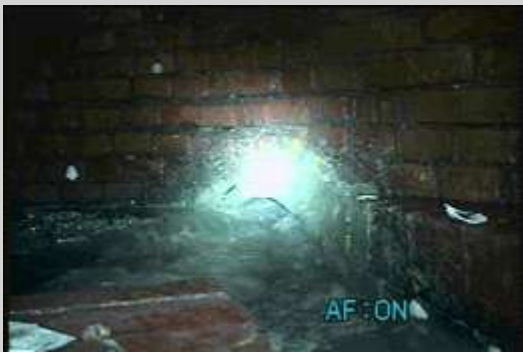
12 O'Clock Outflow

under shelf, as close as camera can get

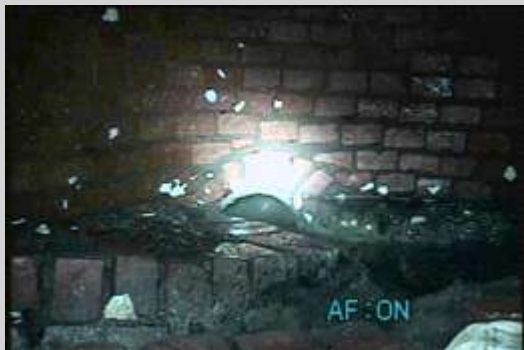
9 O'Clock Inflow

Under shelf, as close as camera can get.
